Title: Research and conservation in Marina el-Alamein in the 2012 and 2013 seasons. The Polish-Egyptian conservation mission.

RESEARCH AND CONSERVATION IN MARINA EL-ALAMEIN IN THE 2012 AND 2013 SEASONS. THE POLISH–EGYPTIAN CONSERVATION MISSION

Dates of work: 1–31 May 2012; 4–31 May 2013

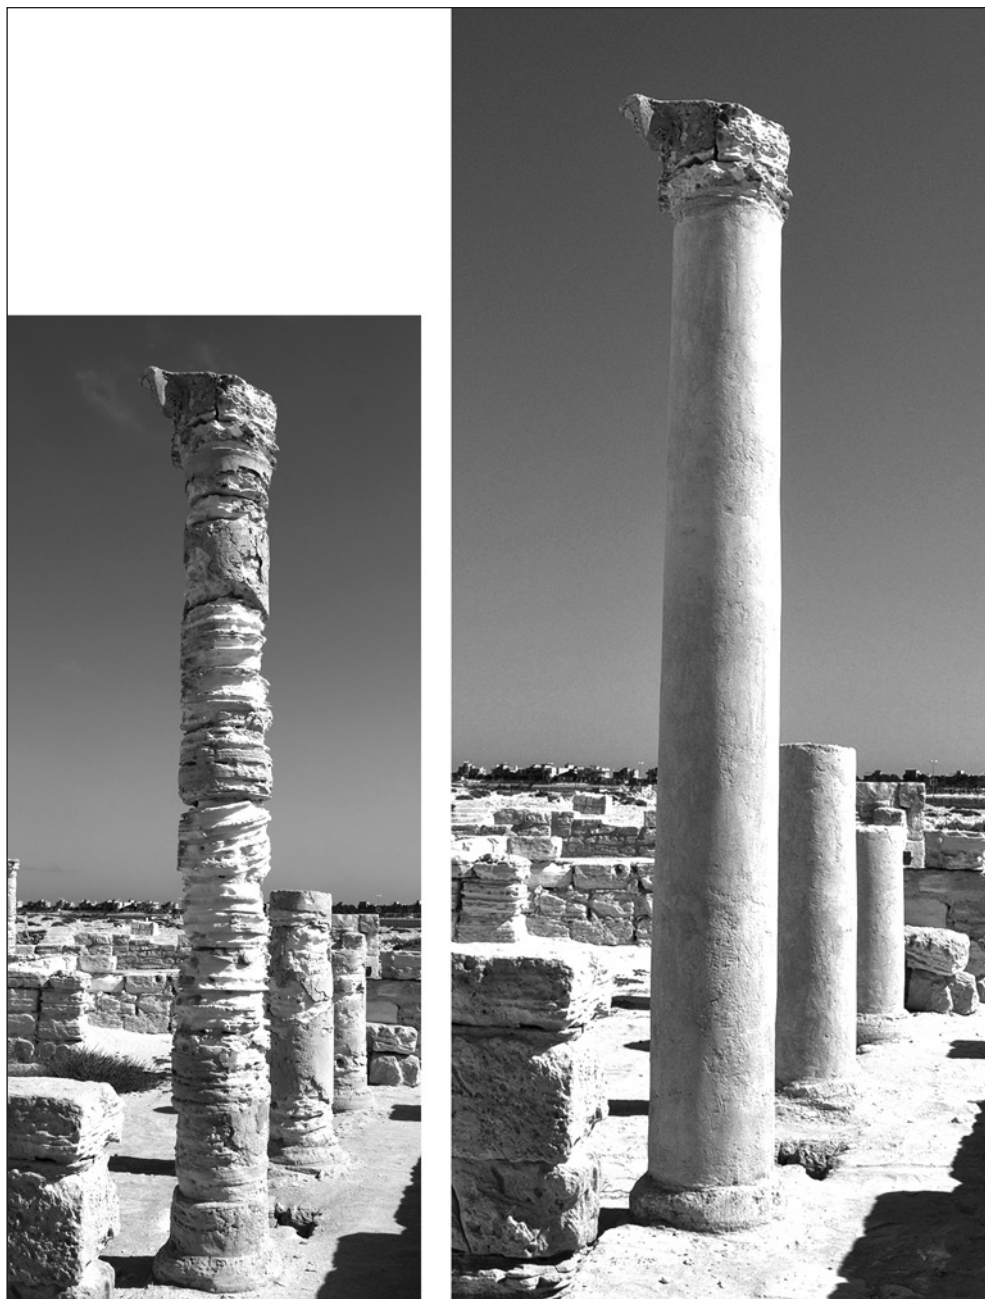
Heavy winter rains, blowing winds and high salinity also caused losses of mortar in joints of columns and powdering of limestone used to built houses **H21c**, **H10**, **H10a**, **H19**, **H2**. A progressing weathering was observed of stones in the wall and the drums of the columns, which

had undergone anastylosis in 1998–2005 [Fig. 5 left]. Original drums had been used then, following a study of the scattering of the elements and replacing missing elements with new drums carved from limestone.

Fig. 5. House H10a. Damaged columns before conservation in 2012 (left) and after (Photos R. Czerner)

Conservation now aimed to clean the side surfaces of stones and the inner spaces of joints, to soak them thoroughly with water and to fill in the losses in joints with lime–cement mortar in standard proportion, and to apply one or several (bigger losses) layers of plaster using lime–cement mortar in a proportion of nine parts sand to three parts lime to one part cement [Fig. 5 right]. White Portland cement and hydrated lime were used.

House H10a: joints and plasters on six columns;

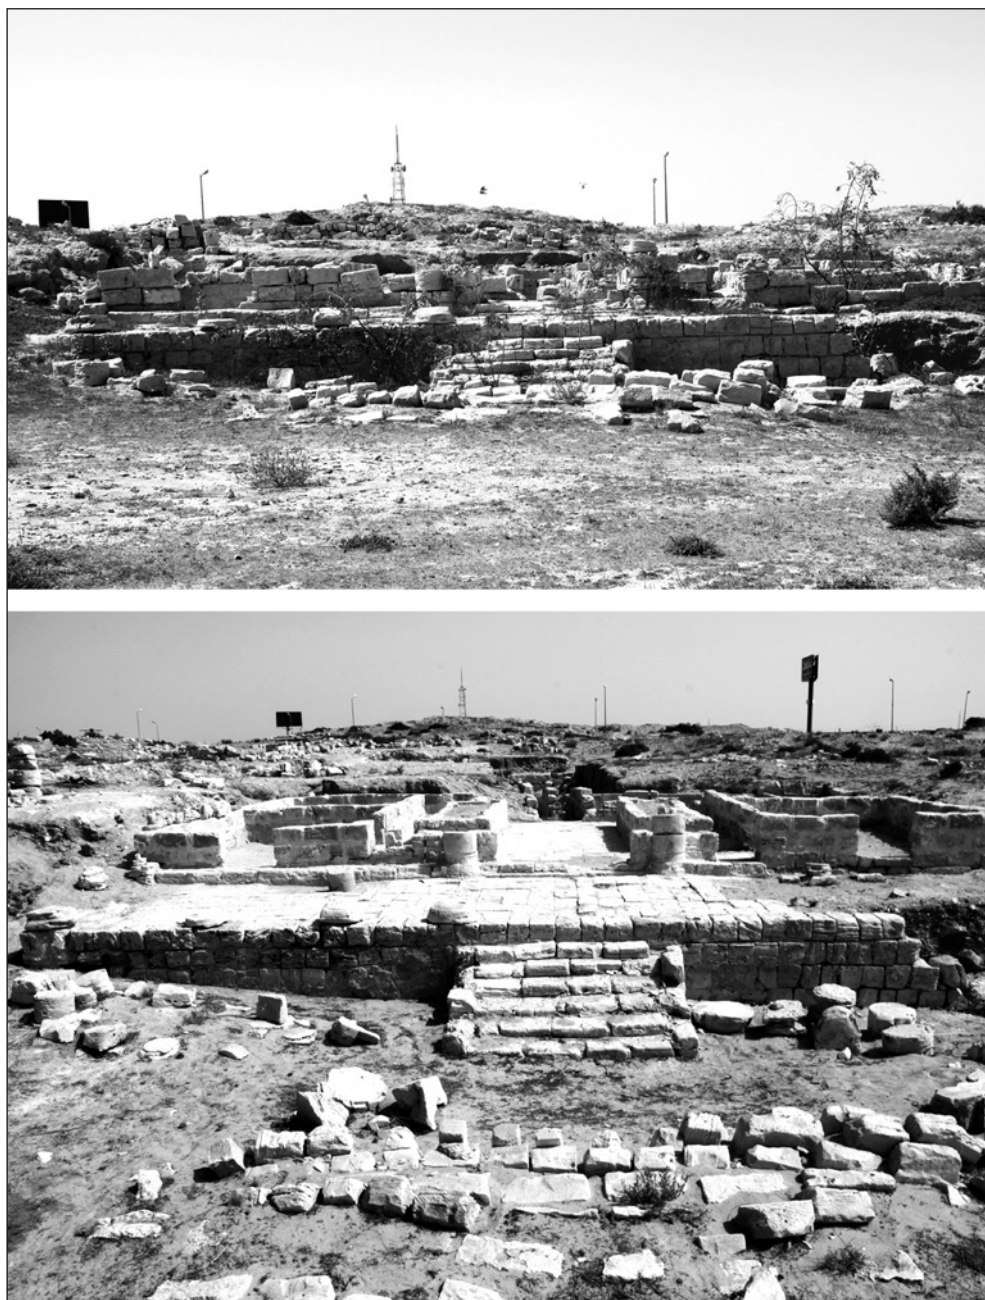
*Fig. 7. Tomb T21. Mausoleum before (top) and after (bottom) conservation in 2013
(Photos R. Czerner)*

Conservation work added a course of stone blocks to the walls of room 1. Blocks from the excavation, which had been stored next to the tomb, were used for the purpose [Fig. 7]. Blocks were cut to size to be placed in the jambs of the entrances. In room 2, some stones from the second course were replaced with blocks that had

a patinated, resilient surface. To the south and to the east, a third course was laid from blocks stored next to the tomb. An original block cut to hold a downspout carrying rainwater into the cistern was left in place (another drain ran into the cistern from the outside of the tomb on the east). The third course in the east wall was laid using blocks sized 0.20–0.24 m by 0.28 m by 0.48–0.54 m.

In the triclinium (room 3), the gaps in the upper course of blocks making up the *klinai* couches were filled in with

material from excavation, stored next to the tomb. Using old stone, two drums of engaged columns were reconstructed and placed on original bases which survived *in situ* on both sides of the main entrance in the front wall. In the eastern part of the portico, a fragment of the stylobate was filled in with original stone.

For masonry work lime–cement mortar with sand, hydrated lime and white Portland cement (6:3:1) was used.
